PRATT AND WHITNEY AIRCRAFT GROUP WEST PALM BEACH FL 6--ETC F/G 21/5  
DESIGN, FABRICATION, AND EVALUATION OF GATORIZED (TRADE NAME) C--ETC(U)  
JAN 79 S A MCLEOD, B H WALKER N00019-74-C-0484  
FR-9787 NL

REPORT DOCUMENTATION PAGE		READ INSTRUCTIONS BEFORE COMPLETING FORM
1. REPORT NUMBER FR-9787	2. GOVT ACCESSION NO.	3. RECIPIENT'S CATALOG NUMBER (9)
4. TITLE (and Subtitle) Design, Fabrication, and Evaluation of GATORIZED Ceramic-Wrought Alloy Attachment Concepts		5. TYPE OF REPORT & PERIOD COVERED Final Report 1 July 1974 through 31 July 1978

20. ABSTRACT (Continue on reverse side if necessary and identify by block number) The attachment of hot pressed silicon nitride material (HPSN) ceramic blades to a wrought superalloy disk, utilizing the GATORIZING® forging process, was developed and demonstrated for application in small gas turbine engines. The development of this hybrid attachment concept consisted of fabricating, optimizing, and evaluating single ceramic blade/wrought alloy attachments by spin testing at ambient and elevated temperatures. The hybrid rotor concept was demonstrated by designing, fabricating, and spin testing several fully-bladed hybrid rotors, some containi

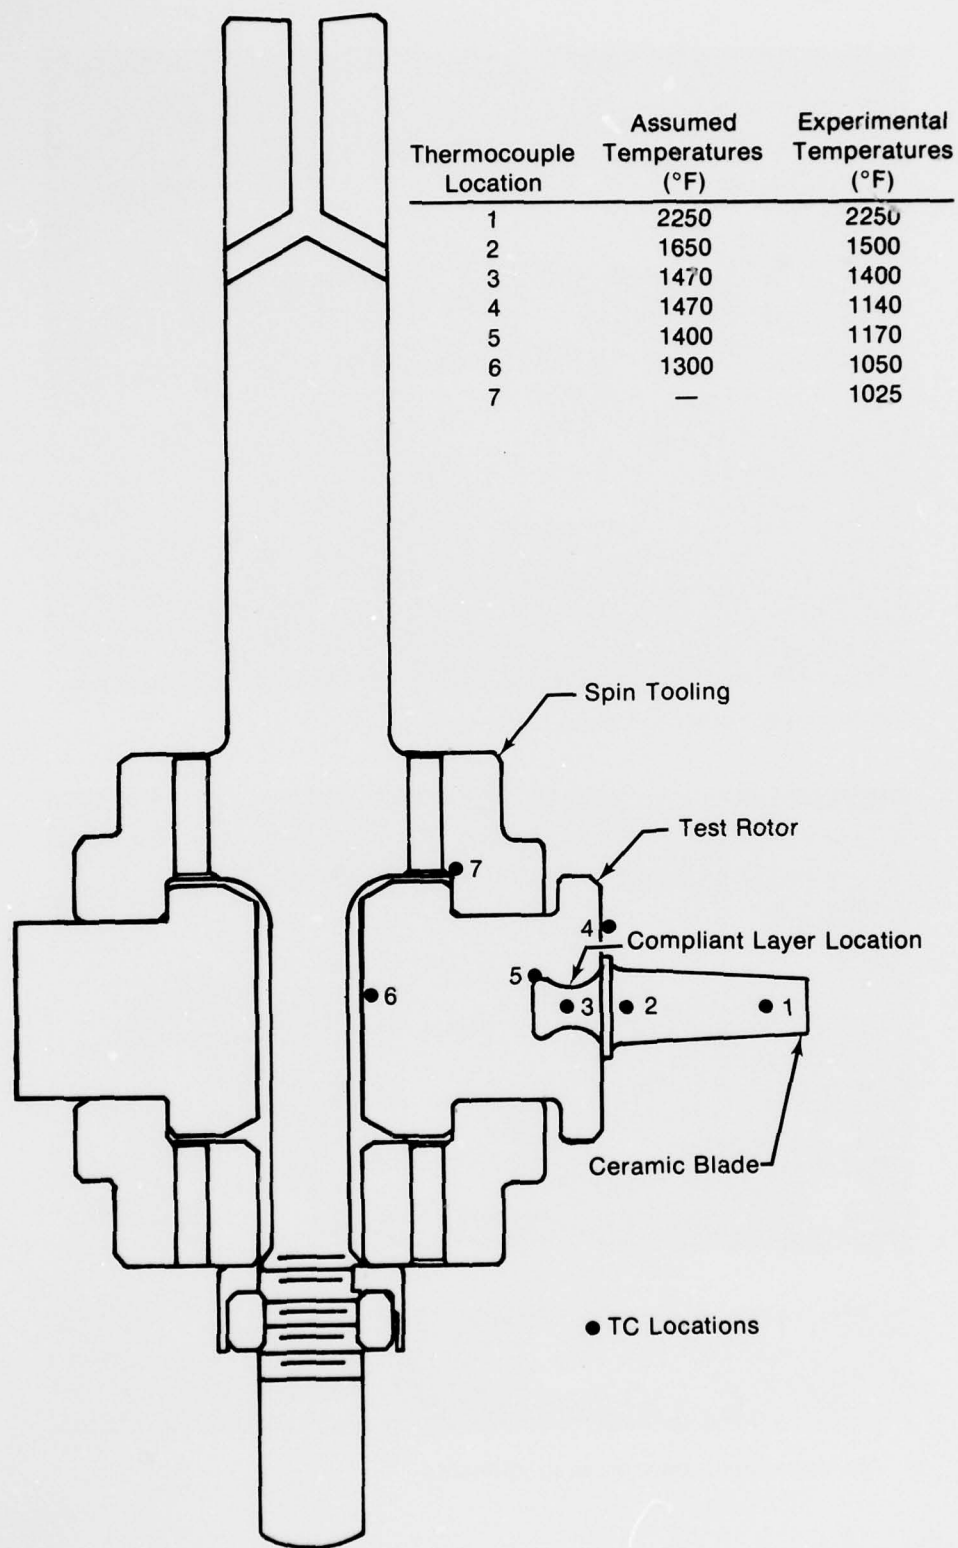
Figure 53. Thermocouple Locations and Temperatures Measured on the Single-Blade Rotor and Tooling

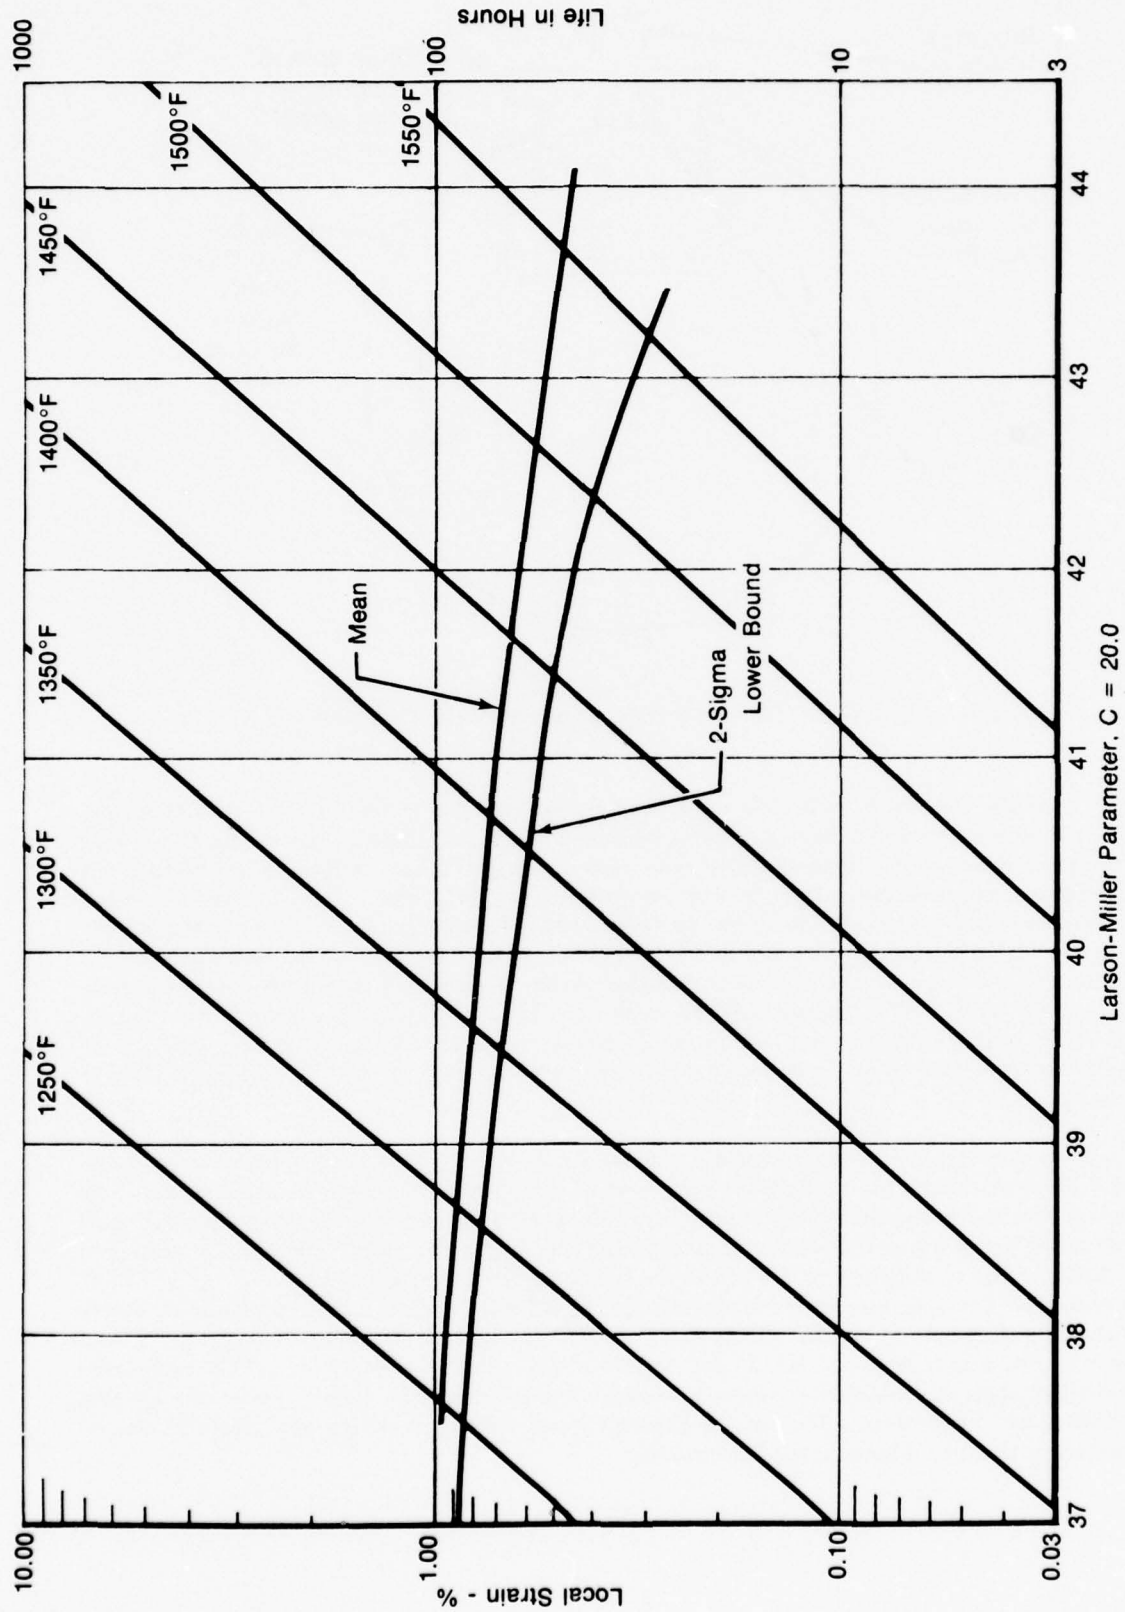
Figure 58. Results of Experimental Analysis of Flat Simulated-Geometry AF2-1DA Specimens

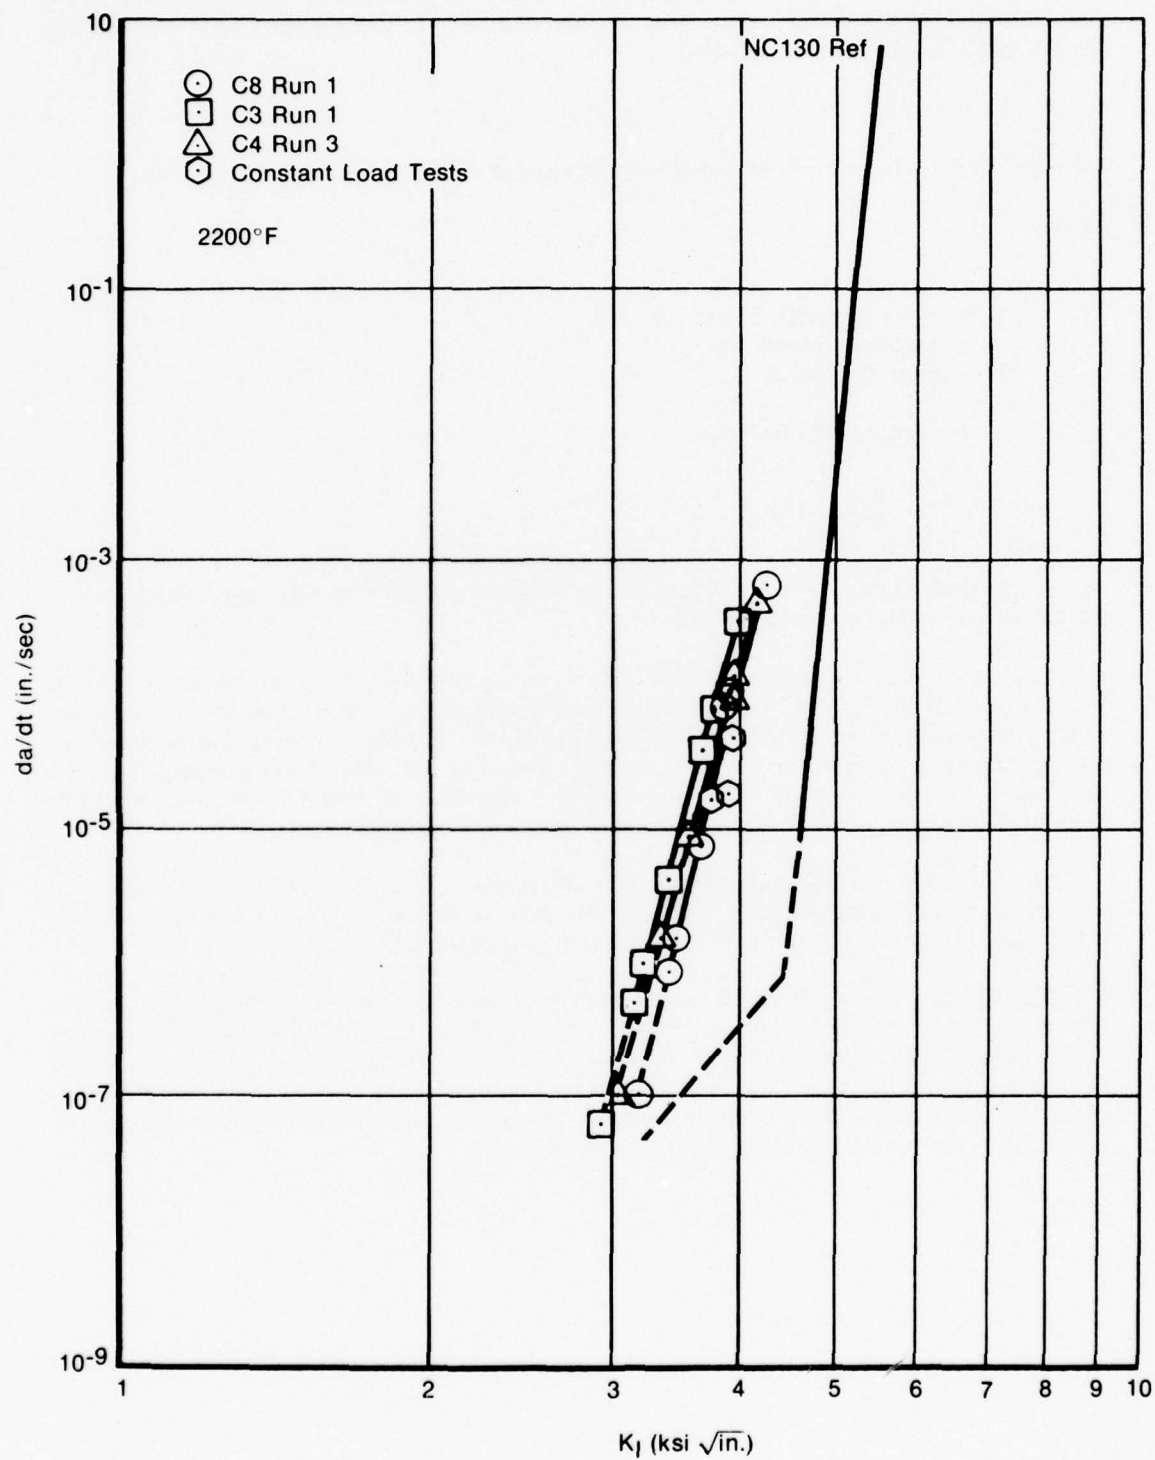
FD 110601A

Figure 59. The NC132 Crack Growth Rate vs  $K_I$  at 2200°F

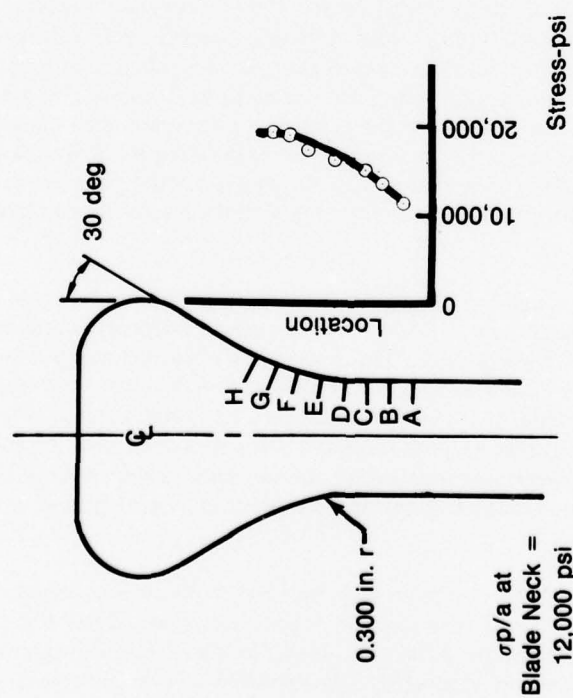
Figure 60. Photoelastic Analysis of Ceramic Blade Root Design

Although no previous photoelastic analysis was conducted on the currently used continuous 0.300-in. root radius blade design, an analysis was conducted on a blade root design using a 30 deg load-bearing surface and a 0.300-in. fillet radius as shown in Figure 60. This analysis indicated that the maximum blade root stress in this dovetail design would be 45% above the P/A blade stress. The P/A stress in the pseudoblade design dovetail is 12 ksi at 45,000 rpm, thus, based on this analysis, the maximum blade root stress is 17.4 ksi.

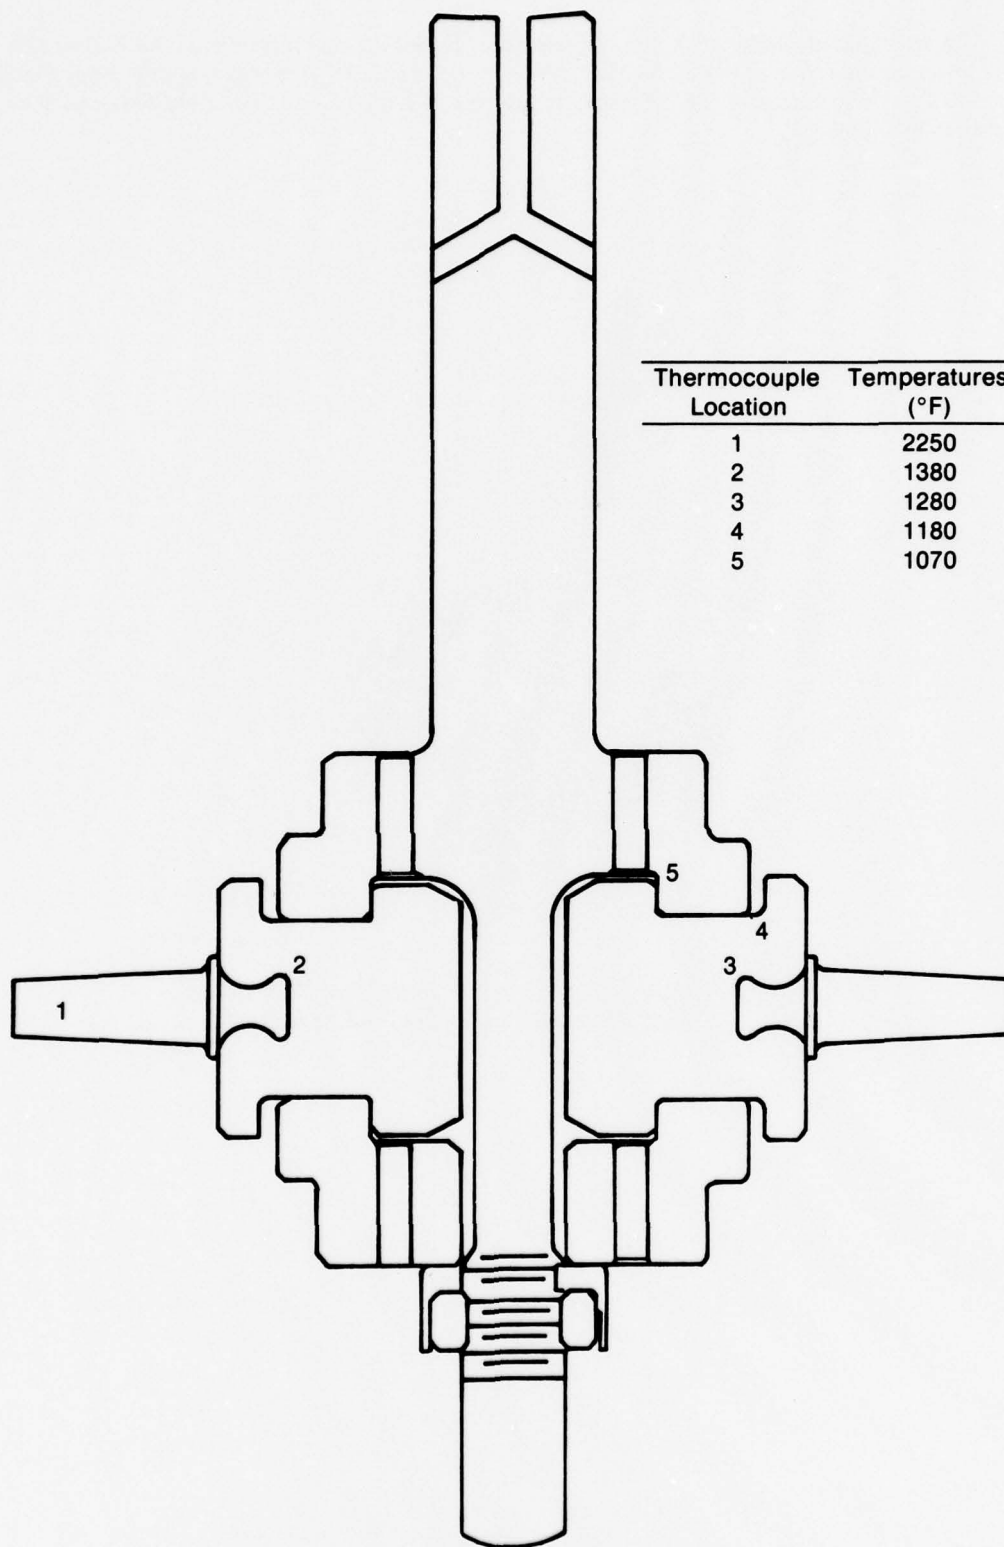
Figure 62. Measured Temperatures for the 28-Bladed Rotor

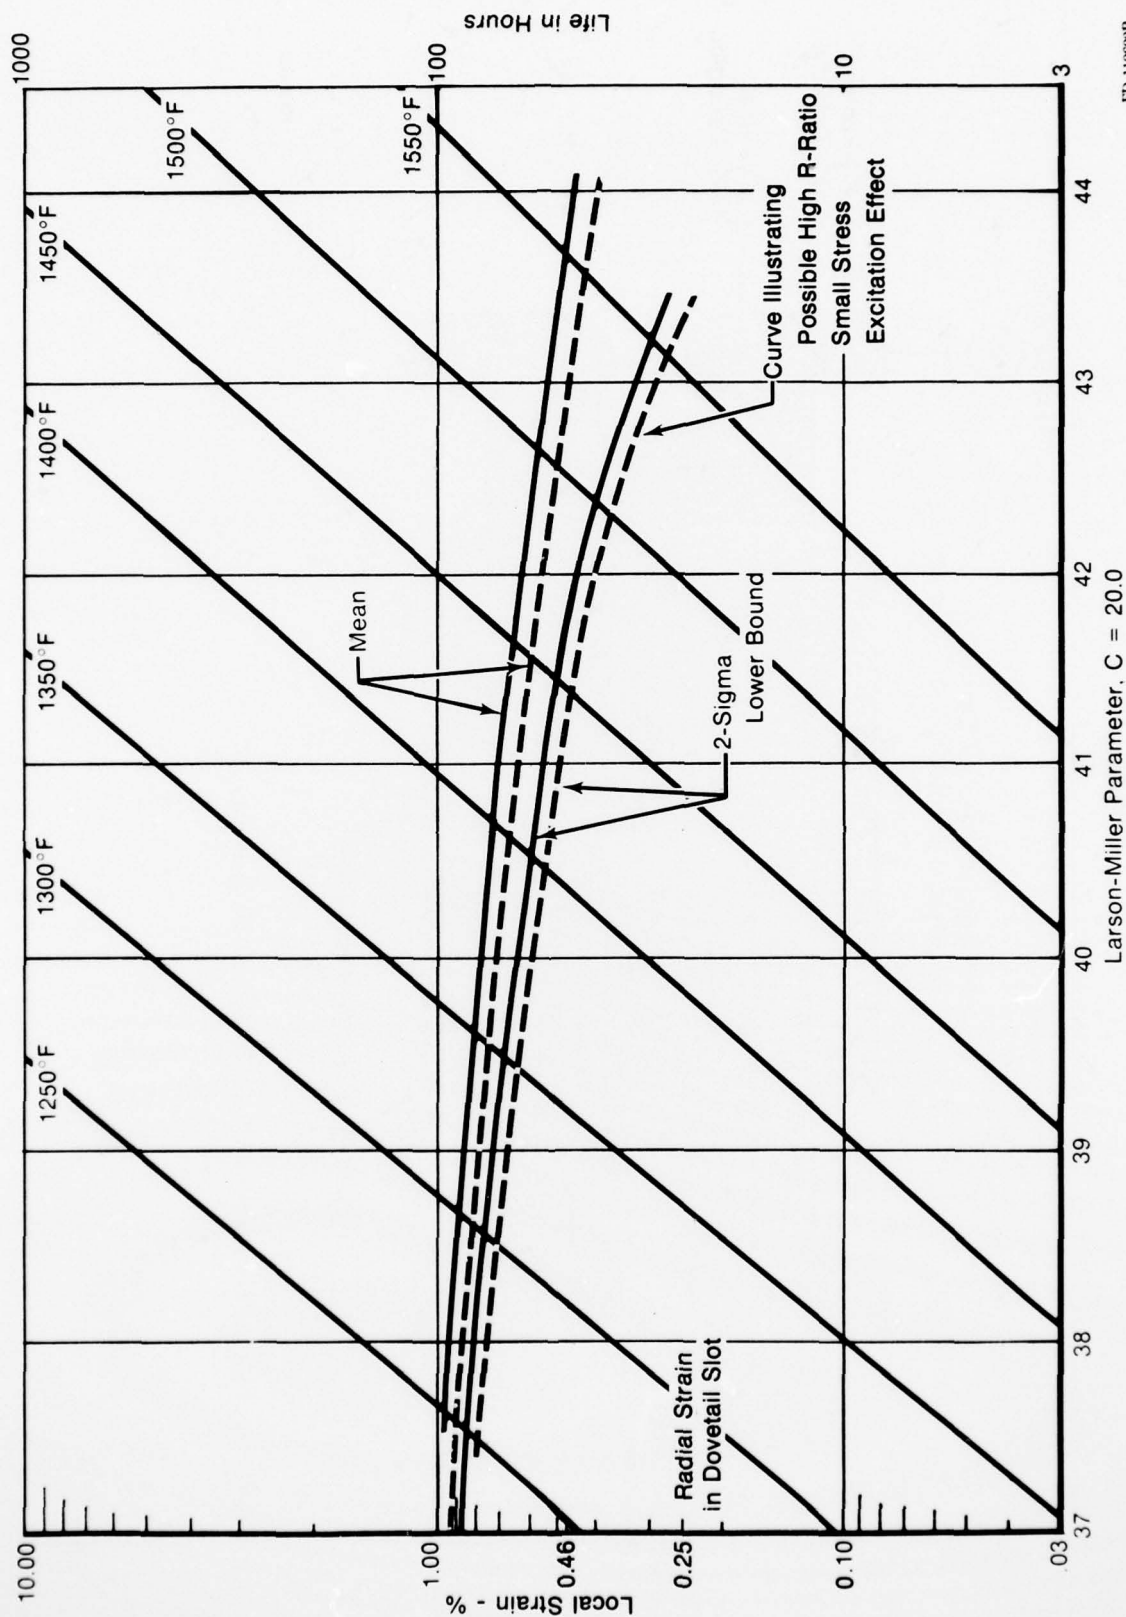
Figure 65. Localized Strain Rupture Characteristics of AF2-1DA Disk Material

The results shown in Table 9 and the AF2-1DA disk material strain rupture data (Figure 65) show that rotor life should far exceed any anticipated test requirements at 60,000 rpm. The maximum strain condition ( $2530 \mu \text{ in./in.}$  at location 4, assuming the hoop strain to be insignificant) is shown in Figure 65 and illustrates that the rotor should not be strain-rupture limited at  $1420^\circ\text{F}$ . This data indicated that a temperature as high as  $1450^\circ\text{F}$  at location 4 would still permit a spin test in excess of 900 hr. However, this conclusion did not include the possible high R-ratio small-stress excitation effect induced by the spin facility drive turbine. This effect was seen in the IN-100 spin rotor during initial elevated-temperature spin testing of six single attachments. During this testing, the high R-ratio small-stress excitation significantly reduced in the IN-100 strain rupture life at  $1500^\circ\text{F}$ . Previous testing to determine the high R-ratio effect on AF2-1DA was conducted at temperatures lower than the  $1380^\circ\text{F}$  attachment temperature shown in Figure 64. As an additional safeguard, however, the high R-ratio effect on IN-100 (50% reduction in strain rupture life of flat strain rupture test specimens) was imposed on the AF2-1DA Larson-Miller strain rupture curve shown in Figure 65. This was accomplished by arbitrarily reducing, by 50%, the life of the specimen test results that produced the original AF2-1DA curve and replotting the curve. The resultant curve is shown in Figure 65. Using the more conservative 97.5% lower bound curve with a strain of  $2500 \mu \text{ in./in.}$  and an attachment temperature of as high as  $1450^\circ\text{F}$ , the expected life of the rotor was still in excess of 500 hr.

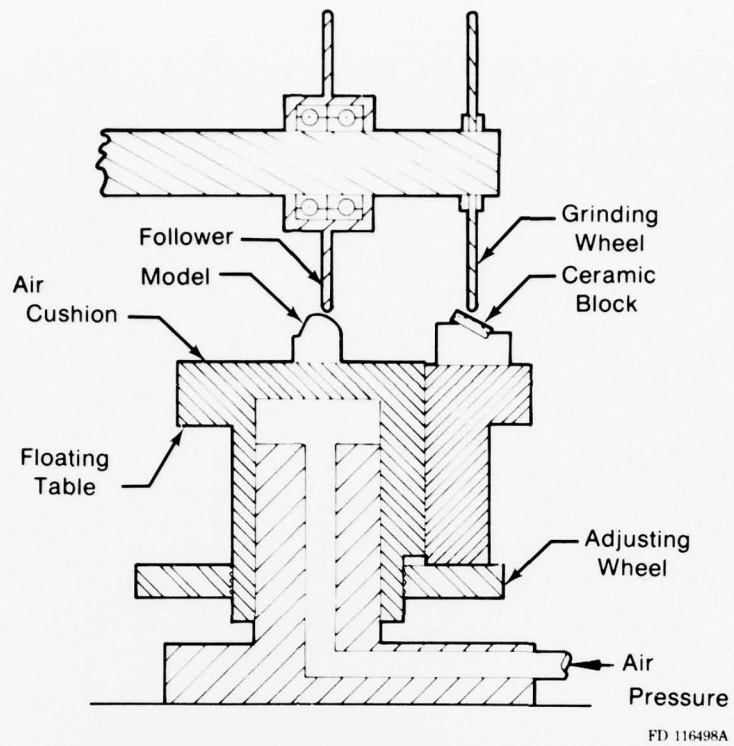
Figure 72. Air Cushion Duplicating Fixture

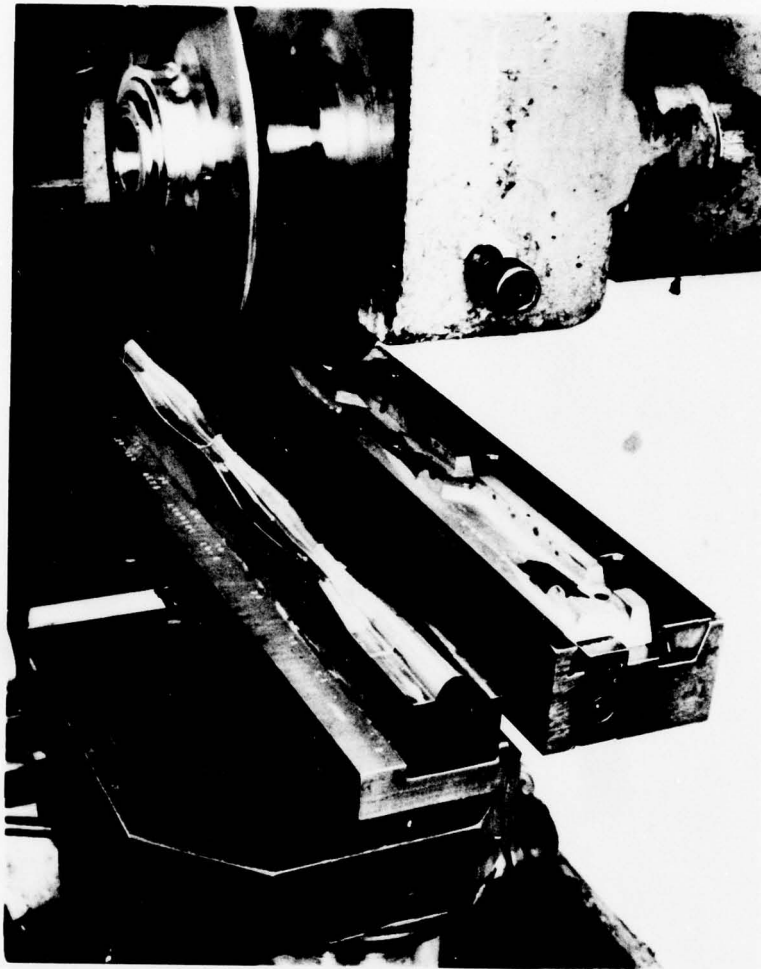
FD 124391

*Figure 74. Set-Up for Grinding Airfoil Convex Surfaces*

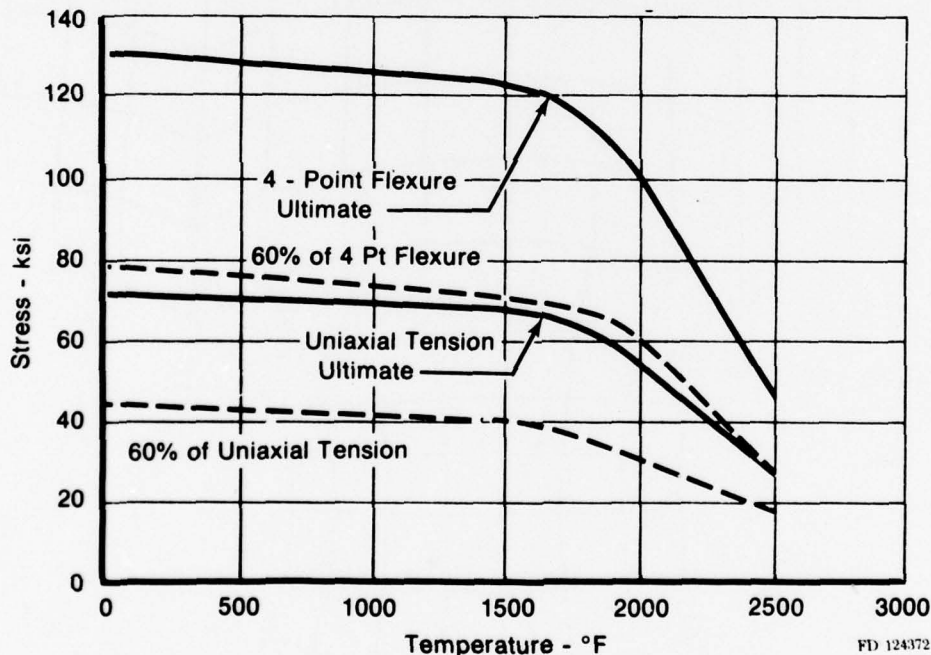
Figure 78. Strength of Hot Pressed  $\text{Si}_3\text{N}_4$ .

Although the initial analysis indicated a maximum stress less than the 40 ksi allowable (using 60% of the uniaxial tensile strength criteria), an additional analytical analysis conducted during the experimental airfoil study indicated a maximum stress that was 18 ksi above this allowable stress (58 ksi). However, since the maximum speed capability of the spin tooling was previously determined to be 53,000 rpm, the 58 ksi predicted maximum airfoil stress (at 60,000 rpm) was recalculated to be 45.3 ksi for 53,000 rpm. Although this stress was still in excess of the 40 ksi allowable, proof testing of each airfoil was planned to substantiate the airfoil design at a rotor speed of 60,000 rpm. Details of this testing are discussed in paragraph 2b.

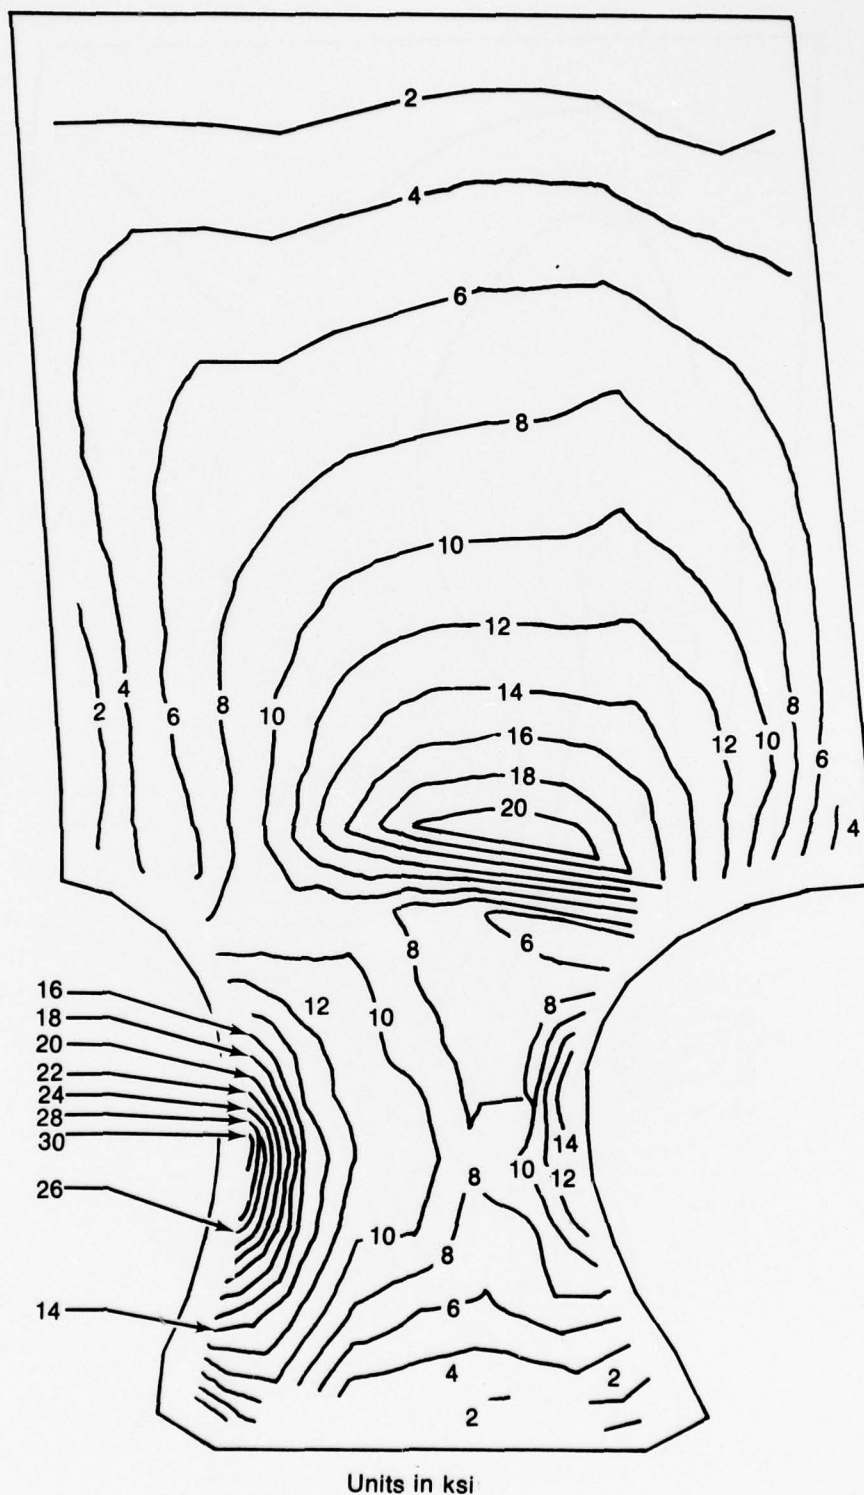
FD 124375A

Figure 79. Major Principal Surface Stress, Concave Side, Combined Loads, Original Model

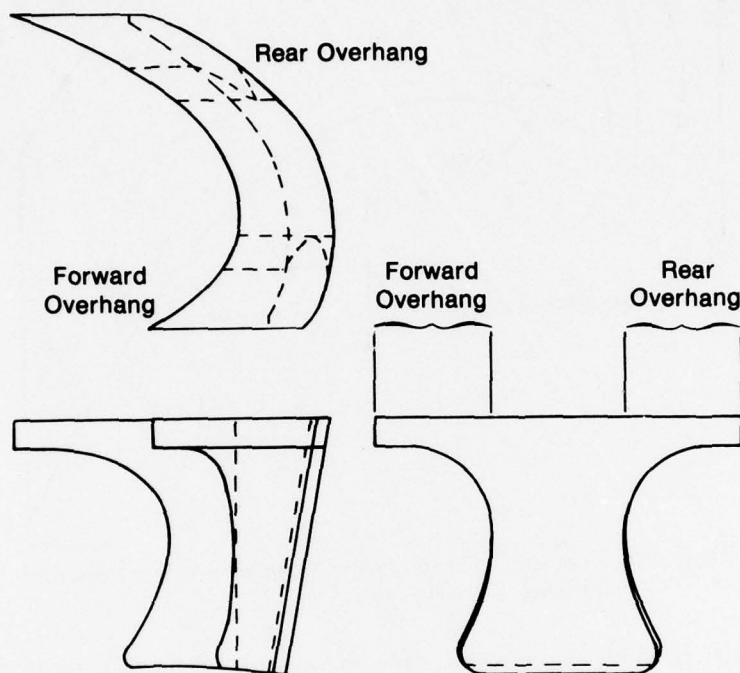
Figure 81. Ceramic Endwall Design

When the airfoil analysis was completed, an analysis of the endwall component design was conducted. Overall loads on the endwall were expected to be low due to the low endwall mass and large attachment cross-section. However, portions of the endwall that overhang the front and rear of the attachment, (Figure 81) would be subjected to considerable bending by centrifugal loading. To simplify the analysis, substructure models of these areas were composed of plate elements and constrained so as to represent attachment to the rigid bulk of the remainder of the endwall.

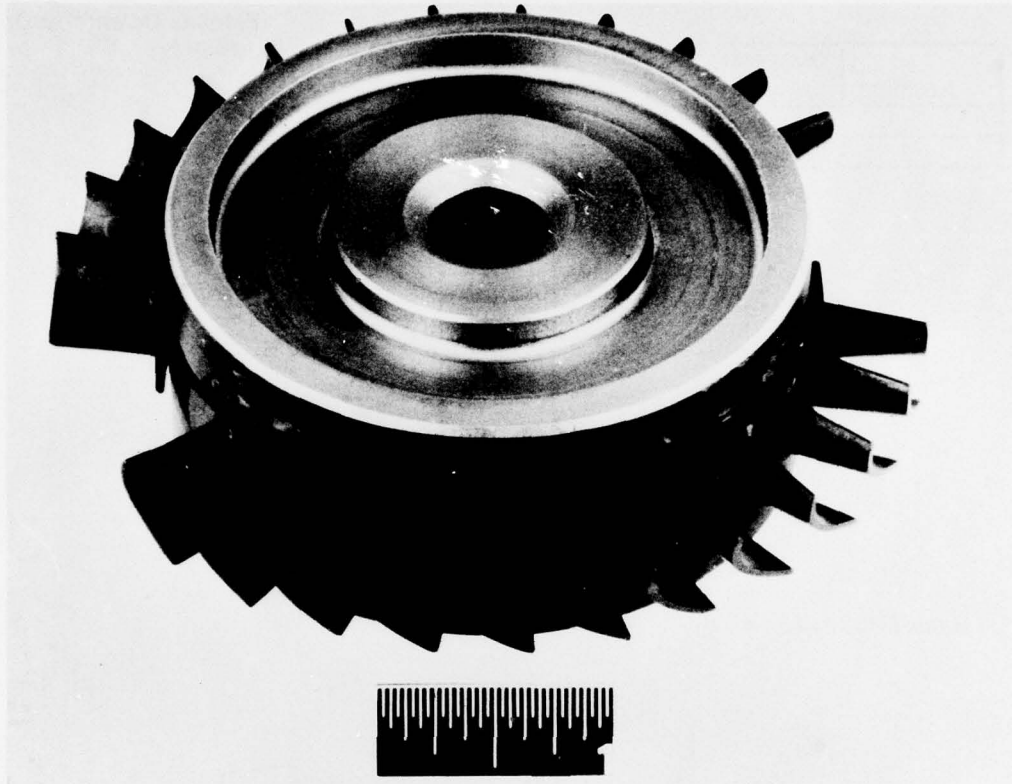
FE 167243

*Figure 86. Hybrid Rotor Prior to Assembly With Spin Tooling*

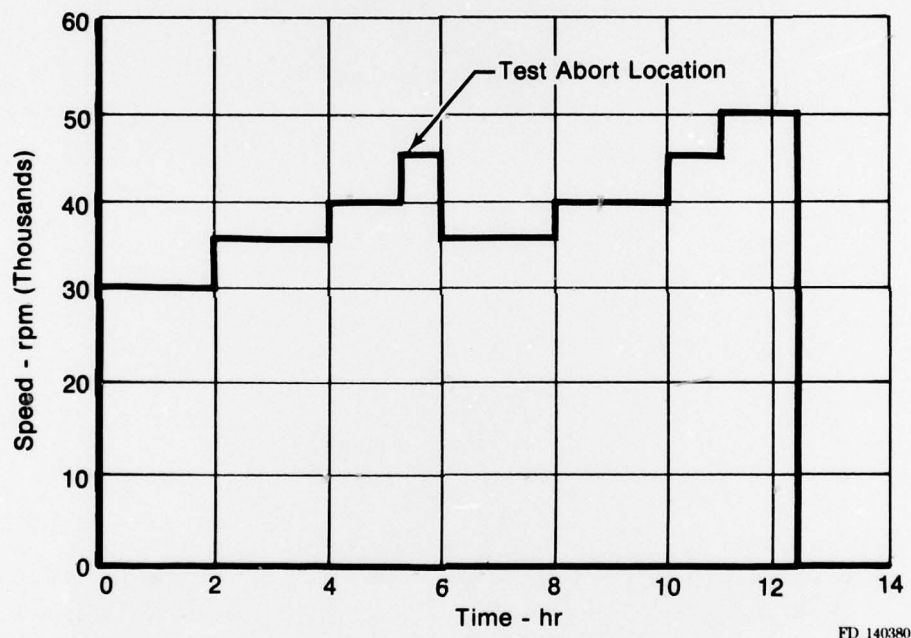
Figure 88. Scheduled Hybrid Rotor Milestone Spin Test Cycle

Following thermal calibration, the program extension milestone spin test cycle was planned. Although previous spin testing during this program was conducted at constant rotor speeds and blade temperatures, the extension milestone spin test goal was changed to more closely simulate a typical 50-hr turbine cycle for a gas turbine engine with this type of technological application. The scheduled test cycle established for this milestone is shown in Figure 88. As shown, the speed was to be varied between 30,000 and 50,200 rpm to simulate the different turbine operating speeds encountered in a typical engine cycle. This cycle was to be repeated four times to accumulate a total of 50 hr of testing at a blade temperature of 2250°F. The maximum rotor speed of 50,200 rpm was chosen for two reasons even though all blades had passed the 120% stress proof spin. First, this speed corresponds to the 60% allowable dovetail maximum stress of 40 ksi (at a 1500°F dovetail temperature as shown in Figure 78) as calculated from the airfoil analytical study results.\* Second, this speed was below the 53,000 rpm speed previously indicated as the maximum allowable spin tooling speed without a tool redesign and build.
